Manhole Inspection Summary

Manhole # S21K__005MH

Insp Date: **4/2/08 1:06 PM**

Location Address: **301 s monroe st**

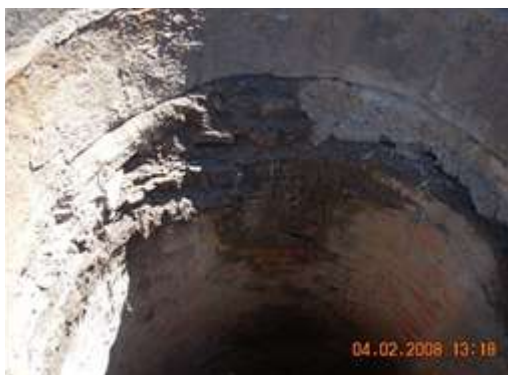
Defect 4

Infiltration: ☐ None ☒ **Joint** ☐ Cracks ☐ Mortar ☐ Roots ☐ Wall

infiltration @ chimney joint

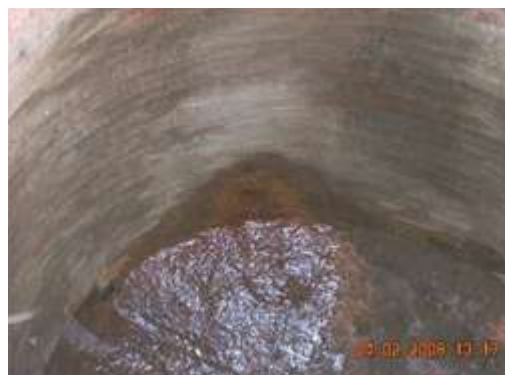
Defect 3

Infiltration: ☐ None ☐ Joint ☐ Cracks ☐ Mortar ☐ Roots ☒ **Wall**

infiltration @ barrel wall

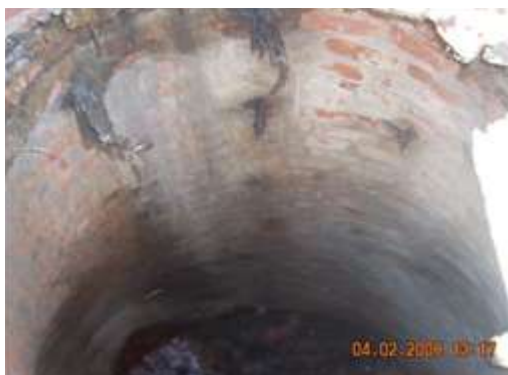
Defect 2

Count: **0** Missing: **6** ☒ **Corroded**

missing steps

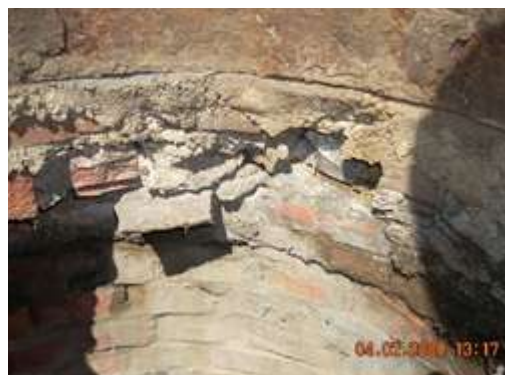
Defect 1

Condition: ☐ Sound ☐ Cracked ☐ Root Intrusion ☒ **Loose Brick** ☐ Deteriorated

loose chimney bricks

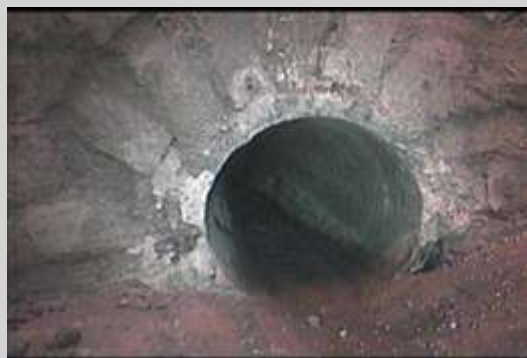
12 O'Clock Outflow

8 in. Circular Gravity Sewer
Pipe Out @ 12 O'Clock

Pipe Height: **8.4** (in.) Rod and Bar (Angled)

Pipe Material: **Clay** ☐ Pipe Lined

Invert Depth: **9.57** (ft.) Flow Characteristics: **None**

Deposits: ☒ None ☐ Mud ☐ Sludge ☐ Debris ☐ Grease

Infiltration: **None** Pipe Seal Cond: **Sound**
